Indoor Tanning Equipment

Care and Use Instructions

**Montego Bay Classic
Wolff 2600B & 3200B**

**100142
REV. 1**

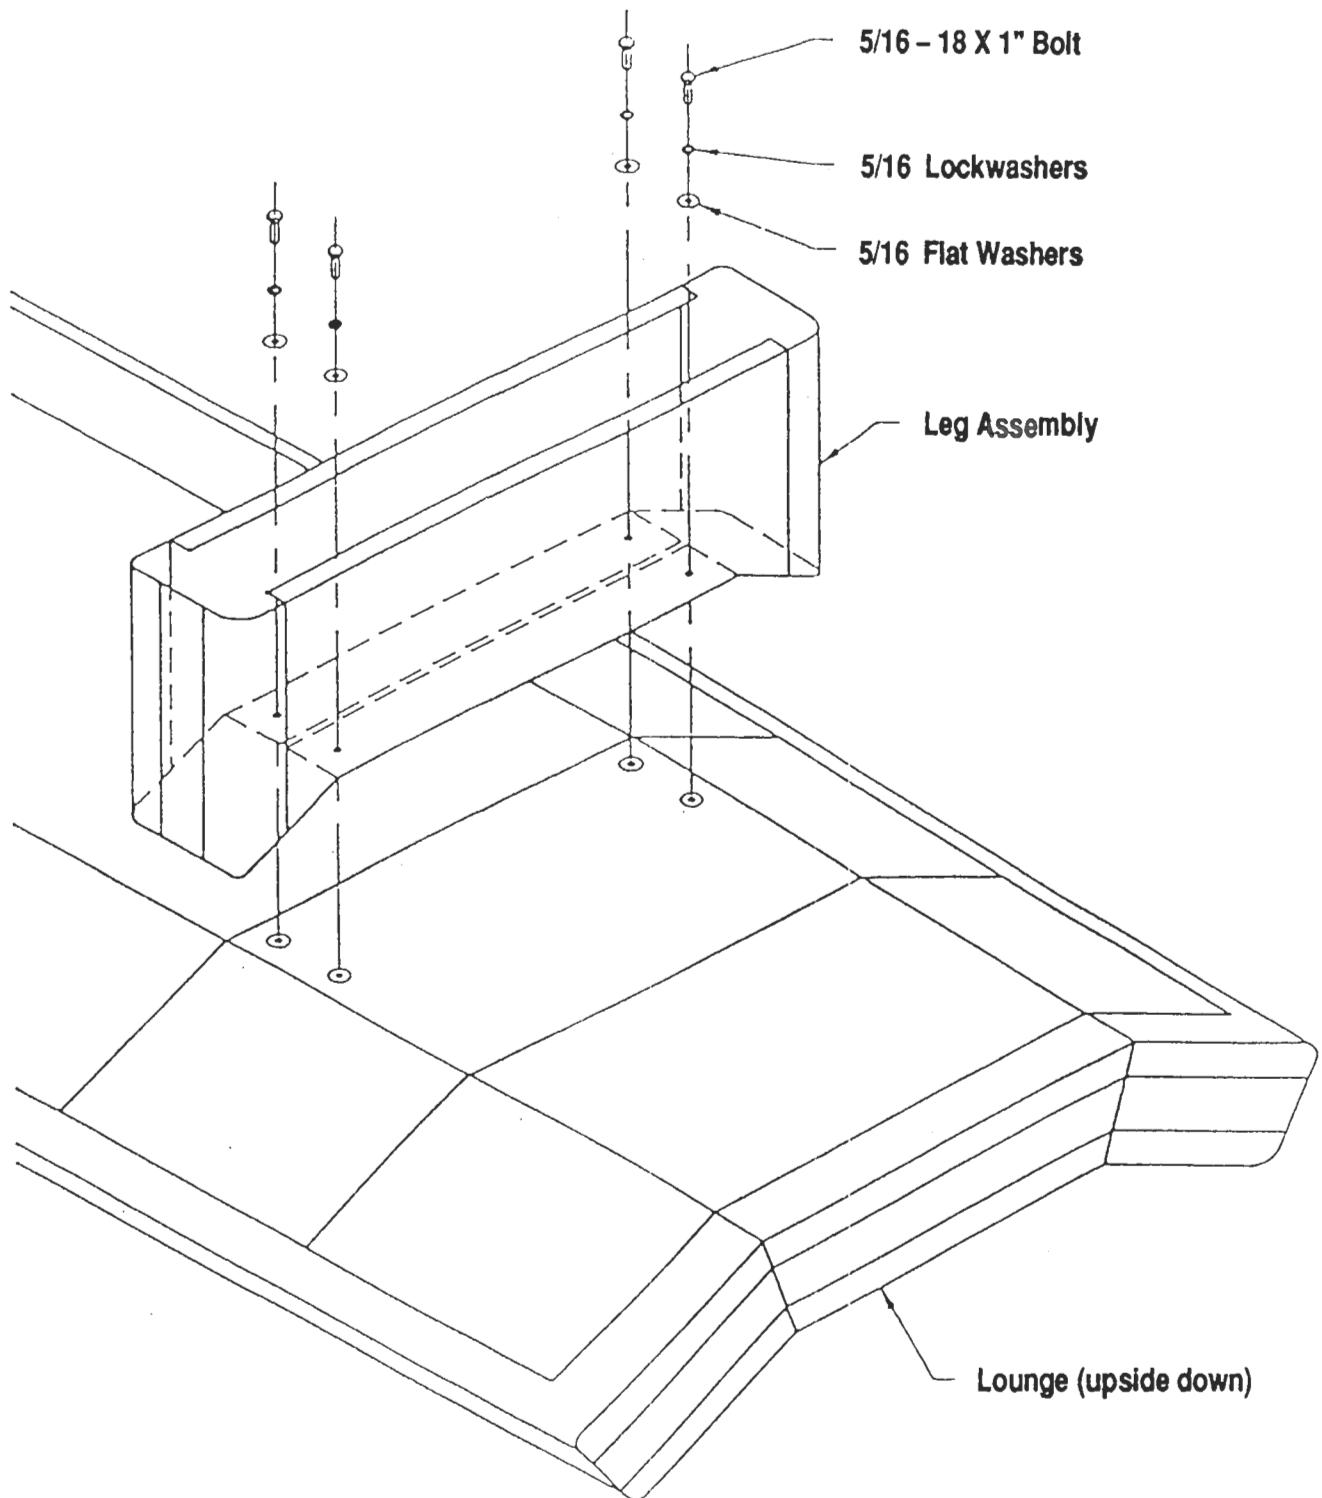
FIGURE #1
Leg Installation

3. Leg Installation (See Figure #1)

a. Turn lounge half of unit upside down and position legs over mounting holes in bottom panel.

b. Attach legs using (4) $5/16\text{-}18 \times 1$ " bolts, flat washers and lockwashers each. Tighten all bolts thoroughly.

c. Turn lounge right side up and rest on legs.

a. Place a leg slide piece on a flat surface and attach an end piece to each end using (4) $1/4\text{-}20 \times 3/4$ " machine screws and $1/4\text{-}20$ keps nuts. (Note: Also use screw dap washer and plastic caps on outer-away from skirt side only.)

b. Flip assembly over and attach other leg slide piece using (4) more $1/4\text{-}20 \times 3/4$ " machine screws and $1/4\text{-}20$ keps nuts.

c. Repeat steps a and b for second leg.

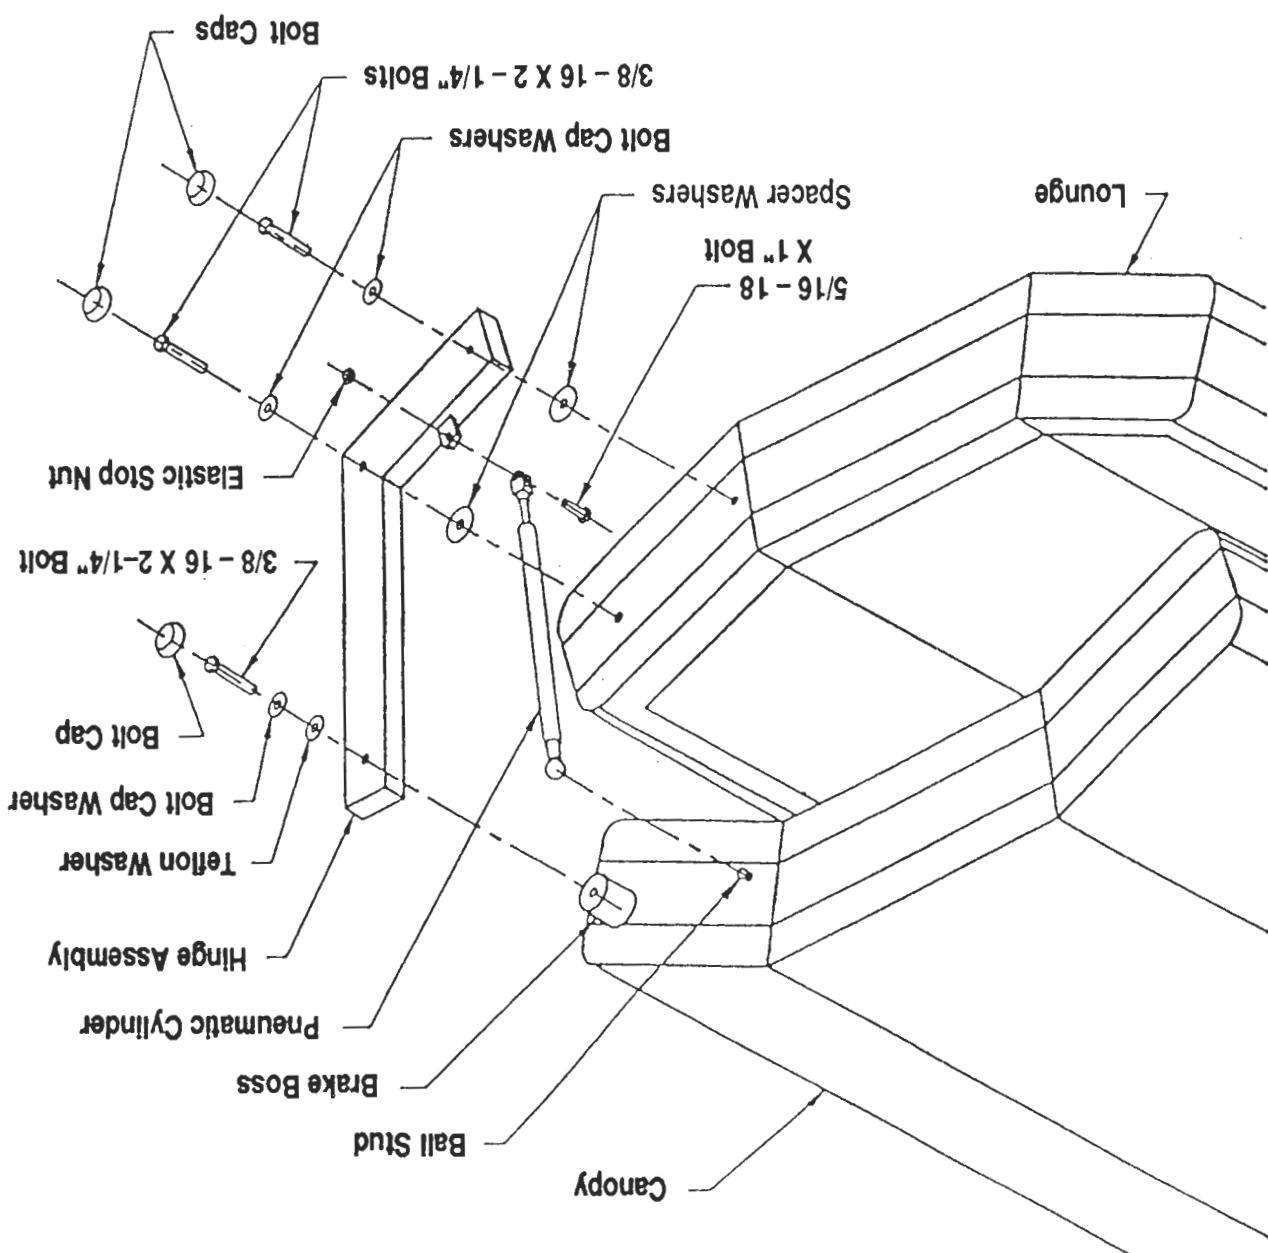
FIGURE #2

a. Attach hinge assemblies (with brake shoes installed) to each end of lounge using (2) $3/8\text{-}16 \times 2 1/4$ " bolts, (2) bolt cap washers and (2) space washers each. Be sure that the side of hinge assembly with large (1.7/8" dia.) hole at top, is on the inside – toward the bed. Do not tighten bolts completely until bolt caps at this time.

b. Attach pneumatic cylinder clevis to tab on each hinge assembly using $5/16\text{-}18 \times 1$ " bolts and elastic stop nuts. Remove wire locking clips from ball sockets at top of pneumatic cylinders.

c. Lift canopy half of unit (with brake shoes attached) and slide bosses into slots in hinge assemblies (top ends of hinge assemblies must be forced outward in order to accomplish this). Insert (1) $3/8\text{-}16 \times 2 1/4$ " bolt, Teflon washer, and $3/8$ flat washer in each end to hold position. With an assistant holding front edge of canopy at full open position, snap ball sockets on the pneumatic cylinders onto ball studs on canopy.

d. Tighten all bolts thoroughly and snap (3) plastic bolt caps into place over bolt heads on each end of unit. Then, adjust brakes (using 5/32 allen wrench in hardware kit) to provide desired ease of operation.

Hinge Installation
